specialist termite control

Date: March 19, 2019.

Client Address: 123 Example Drive Exampletown VIC 1234.

REGULAR VISUAL TERMITE INSPECTION TO AS 3660.2-2017

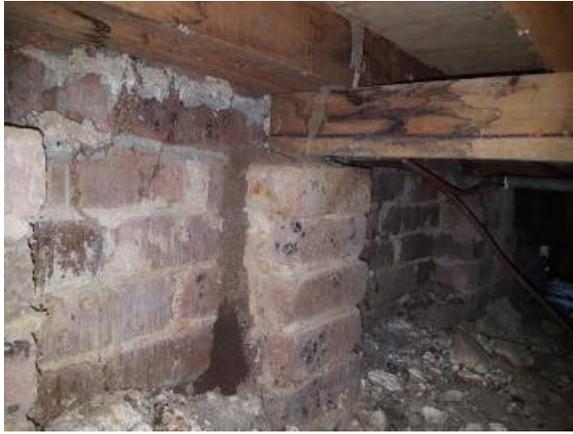
Located below: Dining room.

Live termites in: Floor bearer(s) and floor joist(s).

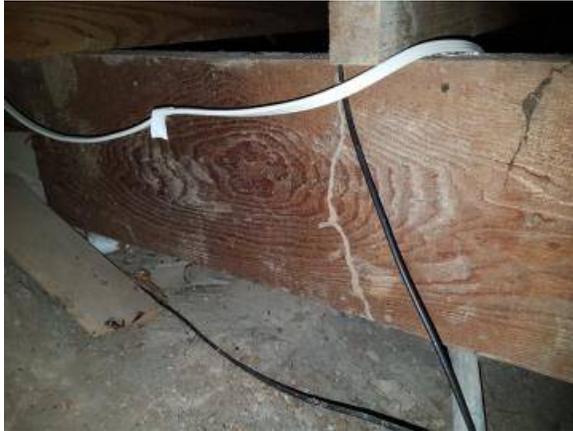
Located below: Main bedroom.

Live termites in: Large section timbers supporting the floor frame.

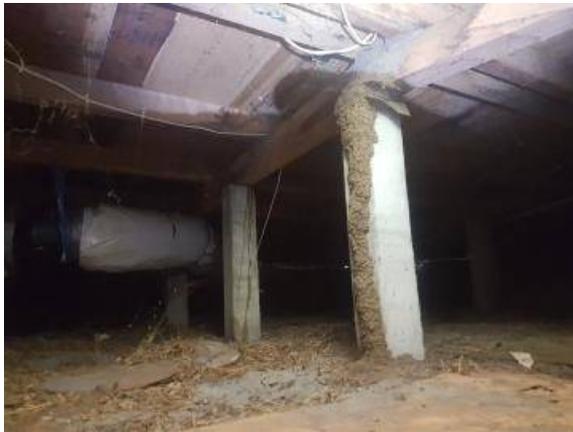
Located below: Kitchen.

Live termites in: Stump(s).

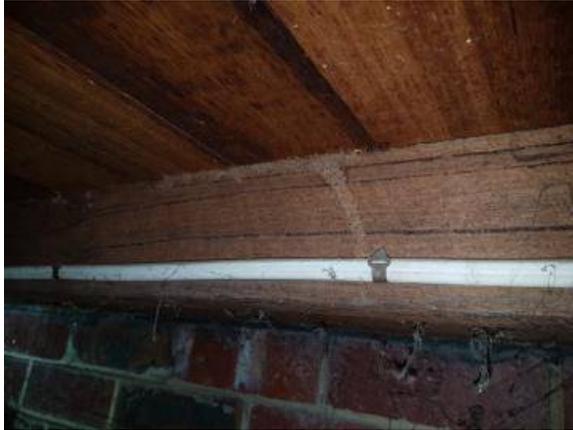
Located below: Ensuite.

Live termites in: Floor board(s).

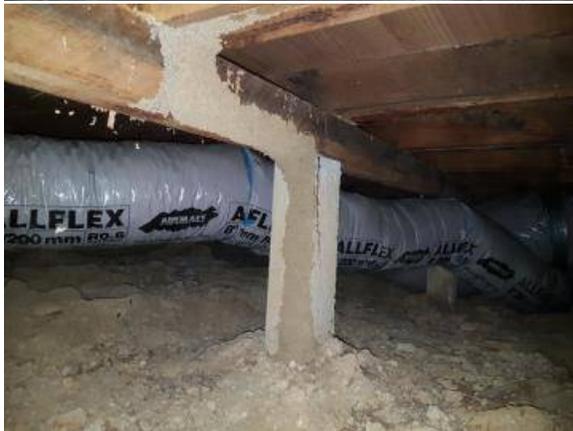
Located below: Family room.

Live termites in: Floor bearer(s), floor board(s), and floor joist(s).

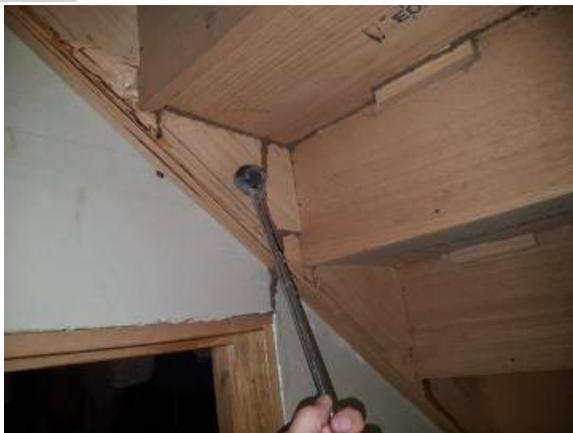
Located below: laundry.

Damage to: staircase timbers.

The termite damage in the appears to be only **'Moderate'**. Please see the 'Termite Damage' information in the terms and conditions section at the end of this report.

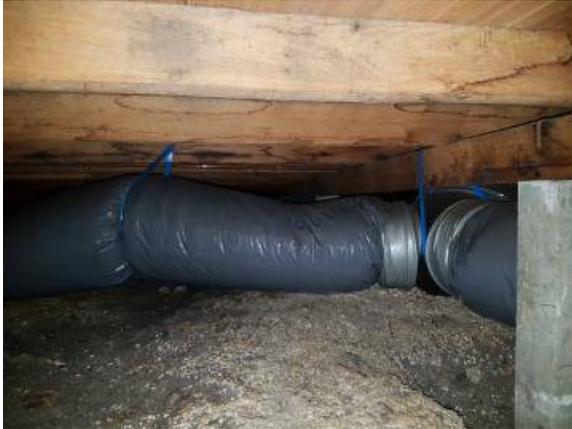
Located below: Family room.

Physical restriction: Ducted heating pipes were located across the subfloor in such a way as to prevent bodily inspection access of that sub-floor area. We recommend that access be created and a further inspection of that area provided. FYG, a sub-floor crawl space of 400mm is necessary to allow safe bodily access.

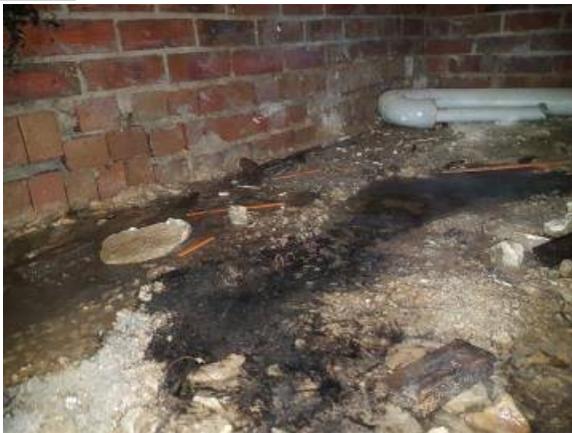
Located below: The front left section of the building as viewed from street.

Condition: The subfloor soil appears wet. This increases the risk of termite ingress and client is encouraged to take measures to reduce this wetness.

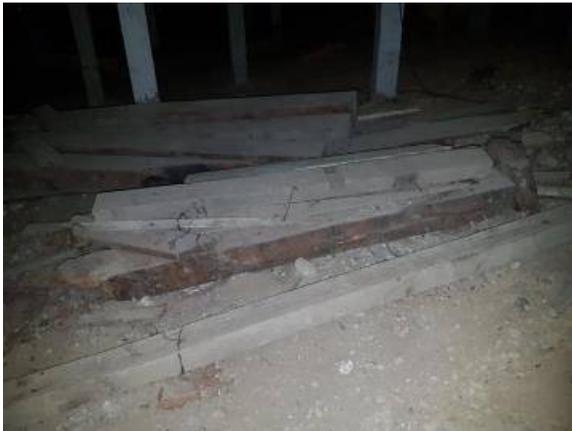
Located below: The mid-section of the building.

Condition: We recommend the removal of stored timbers from the underfloor as timbers in contact with soil are highly attractive to termite attack.

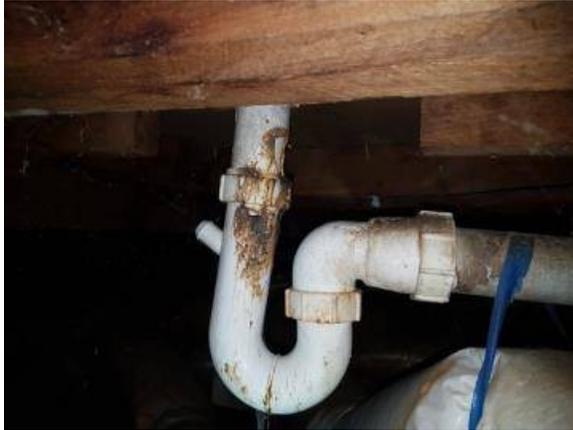
Located below: Bathroom.

Condition: A water leak appears to be present in this area. This should be investigated and rectified.

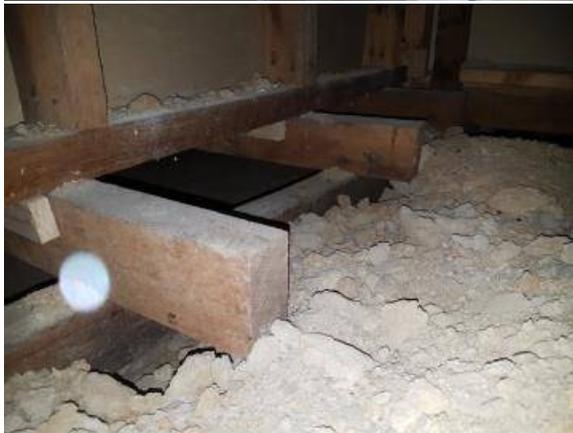
Located below: Extension.

Condition: The floor frame was in soil contact. This allows easy and concealed entry by termites into the building. Building timbers such as these should be isolated from the soil by an air clearance to reduce the risk from termites.

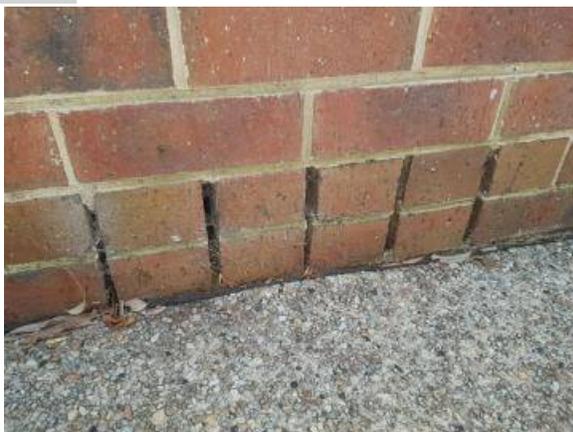
Part of the building is lacking in sub-floor ventilation which increase the risk of termite ingress. The ventilation issue appears to have been at least partly caused by wall air vents that have been obstructed by the air gaps between the brick- gap type air vents being obstructed by webs/ leaves/ rubbish. It is the inspector's experience that brick-gap type air vents do not perform well and replacement with metal air vents is generally recommended.

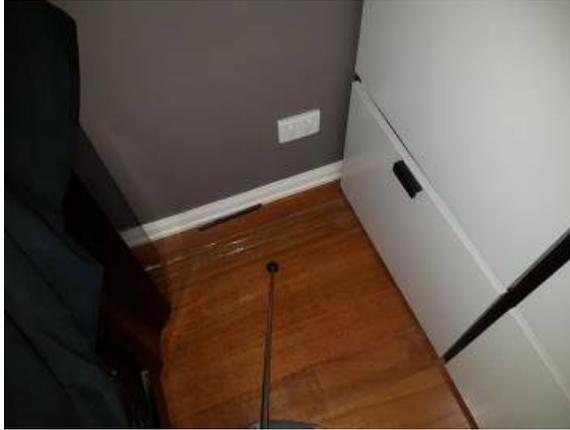
Located in: Main bedroom.

Live termites in: Floor board(s).

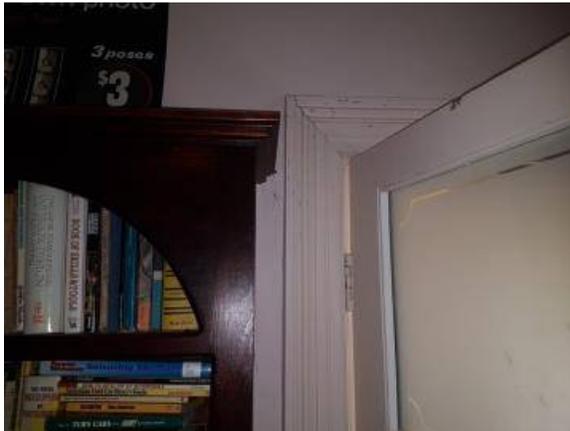
Located in: Office.

Live termites in: Door architrave(s).

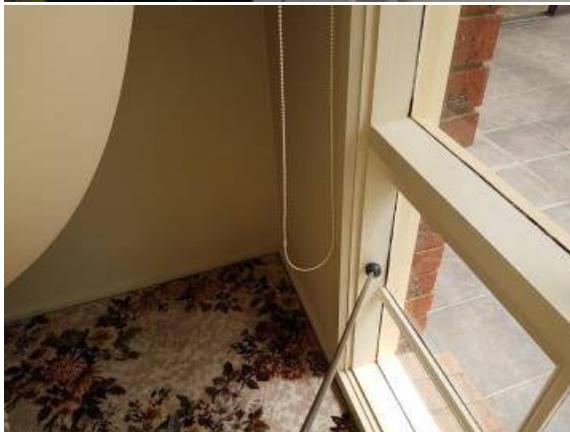
Located in: Dining room.

Live termites in: Window frame/jamb timber(s).

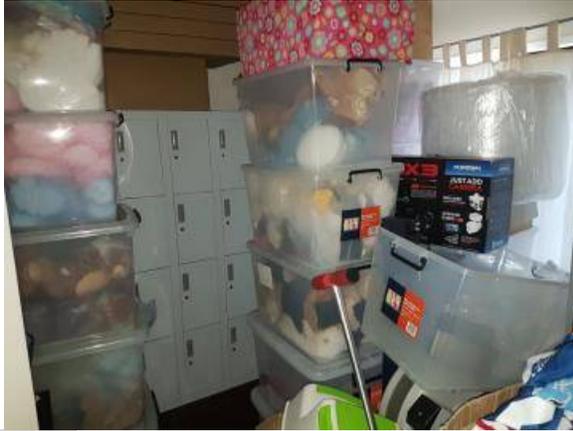
Location: Bedroom 3.

Physical restriction: Stored household goods were present which restricted the inspection. Stored items should be removed to allow a more complete inspection to be carried out.

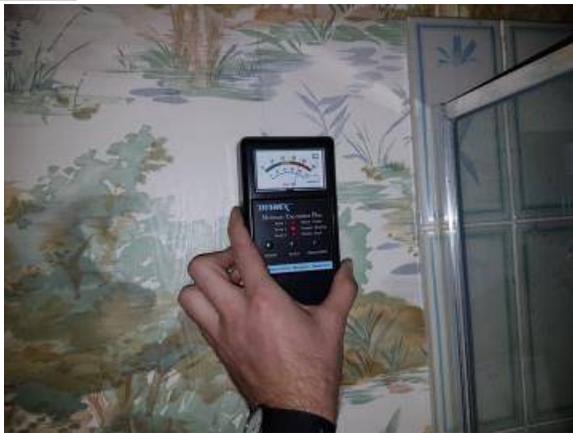
Location: Bathroom.

Condition: High moisture levels were detected in some internal walls as noted below. This can be an indicator of a water leak or possible termite activity. In most cases, such moisture readings are caused by a lack of internal ventilation, heating or the shaded aspect of the location, and the inspector has concluded that this is the more likely cause on this occasion. However, further investigations are available (and recommended) such as removal of some plaster or linings. Please contact the inspector to discuss if you would like to progress this option. Moist timbers are

attractive to termites and increase the risk of termite ingress. Measures should be taken to reduce the dampness if possible.

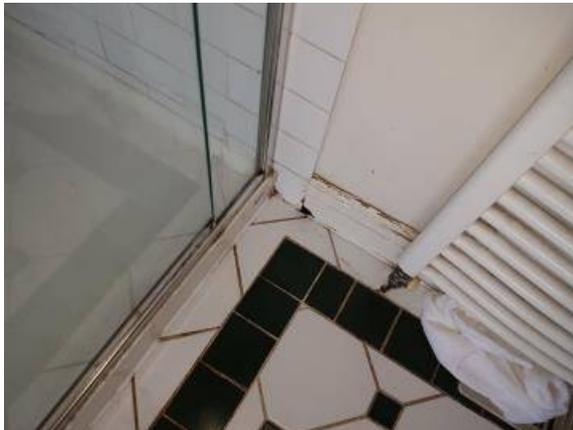
Location: Bathroom.

Condition: Fungal decay was detected in the building interior. While this inspection is not reporting on fungal decay specifically, you are advised that fungal decay may increase the risk of termite ingress into the building. The decayed timbers should be removed, and the moist conditions that have been conducive to this decay should be remedied.

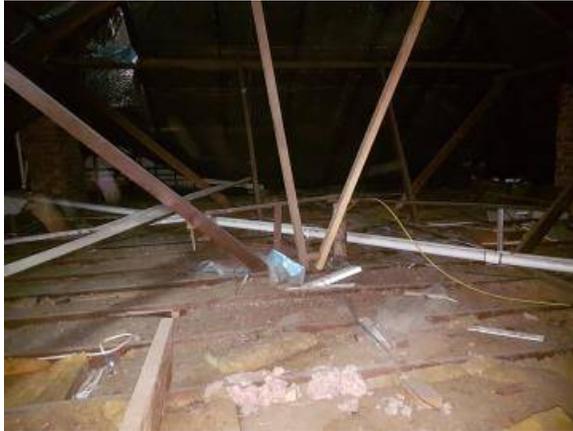
Physical restriction: Physical inspection access was available along the central parts of the roof space, such as under the ridge beams, because access towards the eaves area was limited by restricted crawl space which did not permit bodily access over some critical areas such as the perimeter wall top plates. These were generally obscured by insulation material and could not be visually inspected. However, selected spots along the perimeter wall top plates were "sounded" with a long handled sounder. Note- AS 3660.2, 2017 specifies a crawl space of 600 x 600mm minimum. This means space without

obstructions such as pipes, ducting, and conduits.

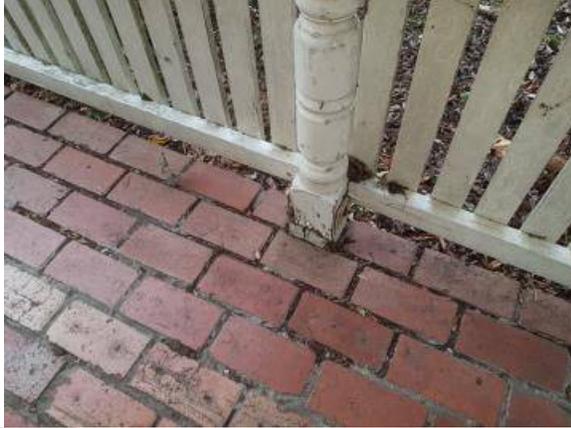
Located externally: Front section of the property (viewed from street)

Live termites in: Verandah post(s).

The termite damage appears to be '**Minor**'. Please see the 'Termite Damage' information in the terms and conditions section at the end of this report.

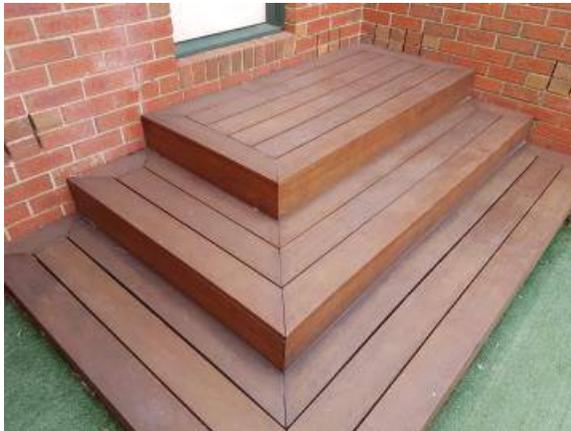
Location: Rear right section of the structure (viewed from street).

Physical restriction: There is insufficient crawl space below decking timbers to inspect under the decking. We recommend that access be created and a further inspection provided.

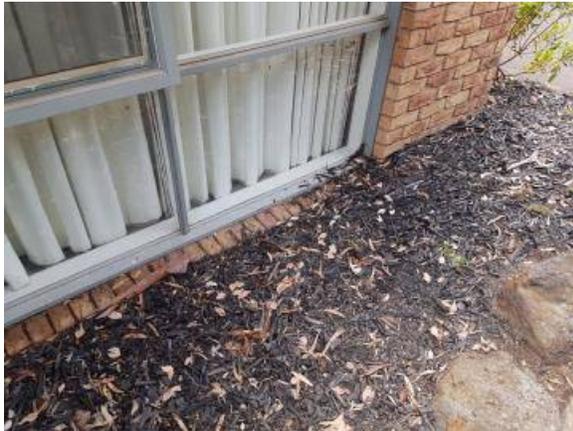
Location: Rear section of the property (viewed from street).

Condition: The finished ground level (FGL) against part of the building is higher than recommended. Since termites live in the soil, a high FGL brings them closer to service timbers (such as wall and floor frames) and increases the risk of termite ingress as well as impedes ventilation. As a guide, the FGL (including concrete or brick paved areas) should be one step (about 150mm) below the floor level of a building. This generally will result in wall air vents or brick weep holes to function without obstruction. In practice, where hard paved FGL is already in-situ, the above may be difficult to achieve and other

options may be available. We recommend that client discusses this with the inspector or calls the office to talk with a specialist.

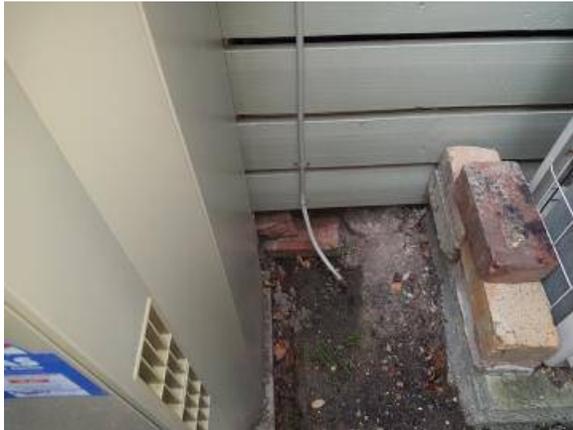
Location: Rear left side of the building (viewed from street).

Condition: The hot water system overflow is discharging moisture close to the building. This can provide an attractive environment for termites and we recommend that the overflow pipe is either plumbed into the storm water system, or extended to discharge well away from the building.

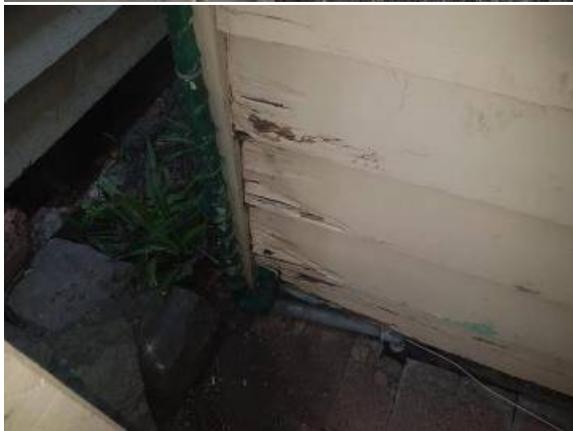
Location: Rear left side of the building (viewed from street).

Condition: Fungal decay (rot) was detected. While this inspection is not reporting on fungal decay specifically, you are advised that fungal decay may increase the risk of termite ingress into the building. The decayed timbers should be removed, and the moist conditions that have been conducive to this decay should be remedied.

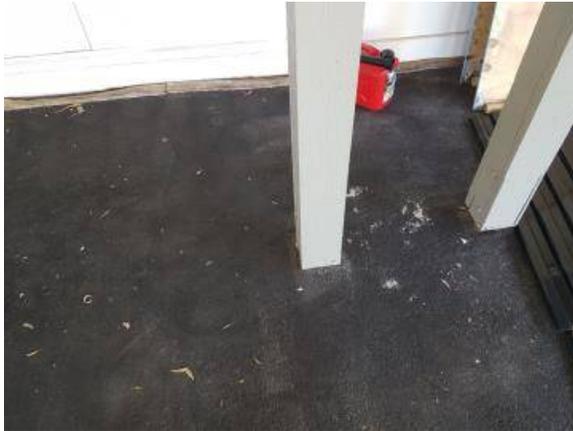
Location: Front section of the property (viewed from street).

Condition: Timber posts in soil contact. The soil contact with timber posts should be removed. Non-durable timber posts such as Oregon pine should be permanently separated from soil contact, typically by mounting in a steel stirrup, which should hold the post clear of soil contact.

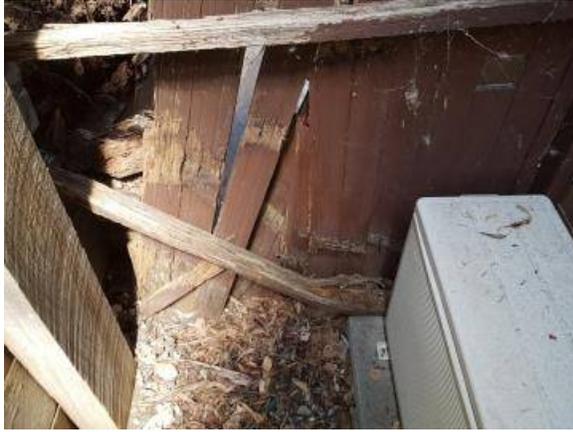
Location: Left side of the property (viewed from street)

Live termites to: Timber fence.

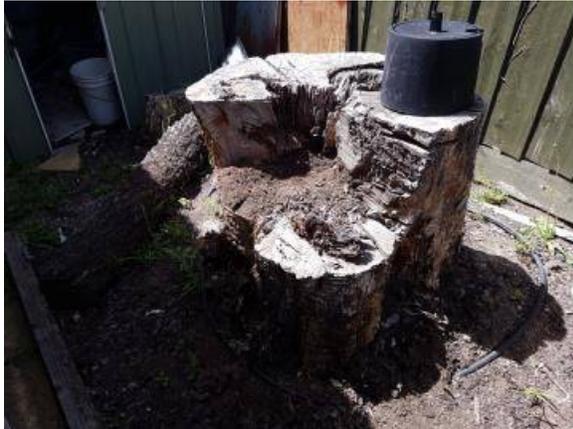
Location: The back garden.

Live termites to: A tree stump.

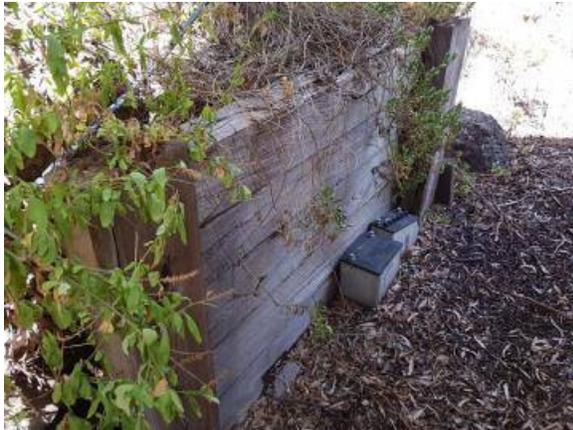
Location: The back garden.

Condition: Untreated landscaping timbers should be removed or replaced with a treated timber or non timber alternative. If replaced with timber, ensure appropriate durability rating for external use.

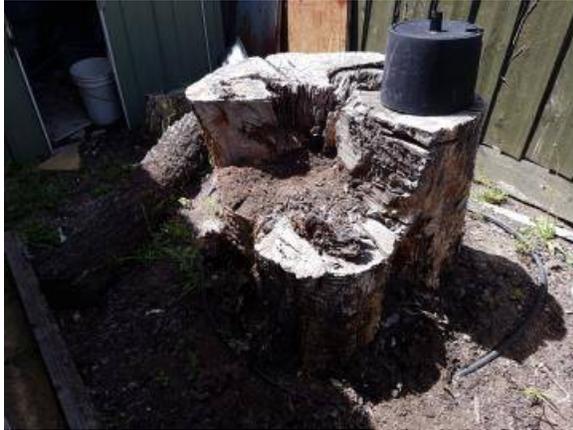
Location: The back garden.

Condition: Tree stumps should be removed. This is because tree stumps left over time can be highly attractive to subterranean termites.

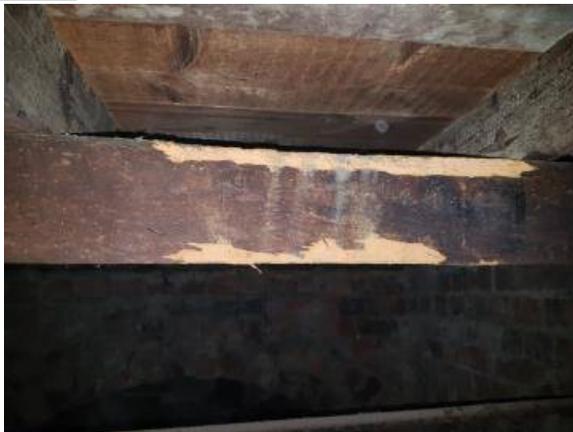
- Location - Floor bearers in part of front section of the building.

- *Lyctus brunneus* (hardwood borer) - *Lyctus* borer attack the sapwood of susceptible hardwood timbers and are not generally a problem structurally and typically are not considered to require any treatment.
